Cascaded two-tank: unmeasured step in tank-2 leak ( $k_3$ )

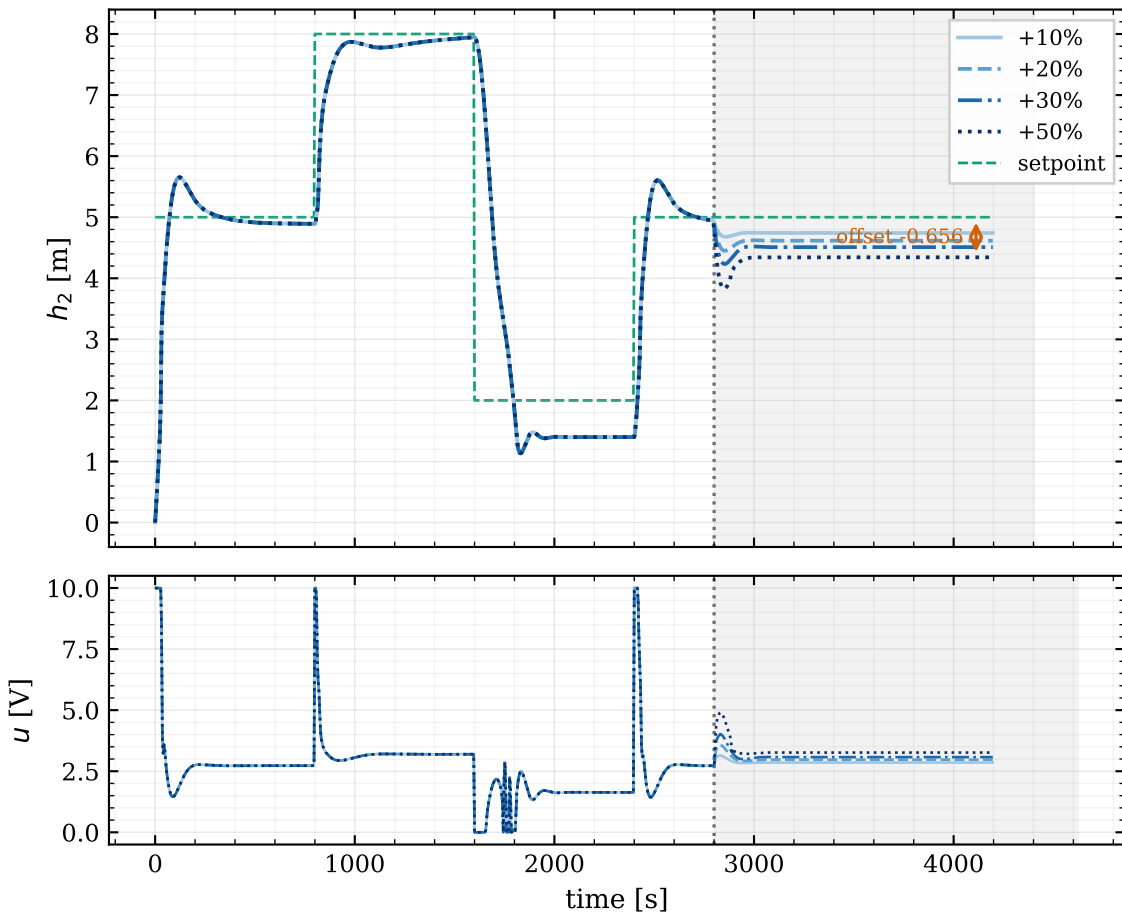
The disturbance is active over the shaded span. It is unmeasured: no controller input carries it.
